Name of Dam: Camp Shenandoah Dam.
Location: Augusta County, State of Virginia
Inventory Number: VA 01515

PHASE I INSPECTION REPORT
NATIONAL DAM SAFETY PROGRAM.

Camp Shenandoah Dam (VA 01515).
Potomac River Basin. Augusta County,
State of Virginia. Phase I Inspection
Report.

SEPTEMBER 1978

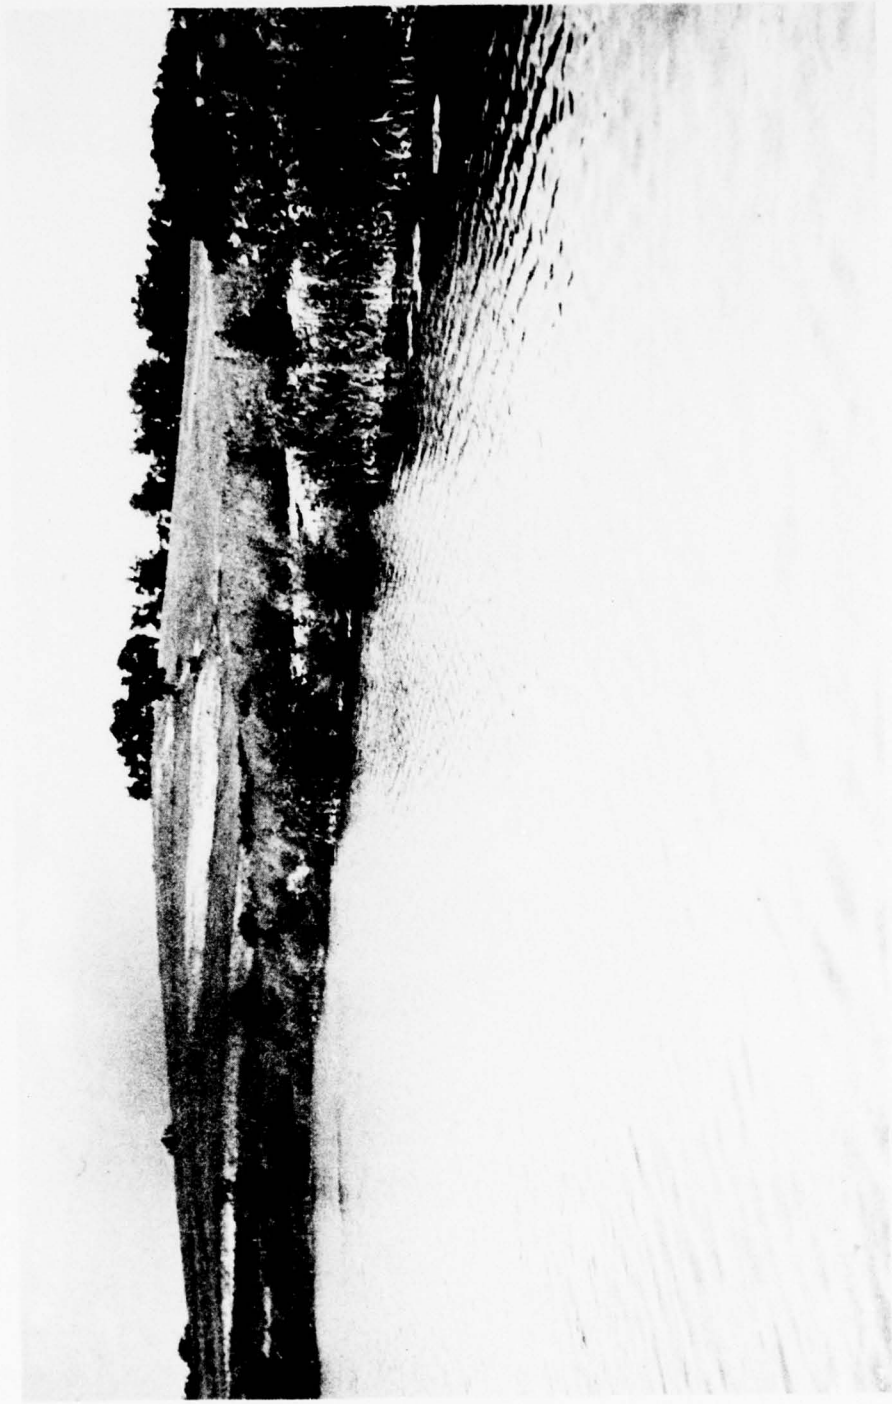
OVERALL VIEW OF DAM

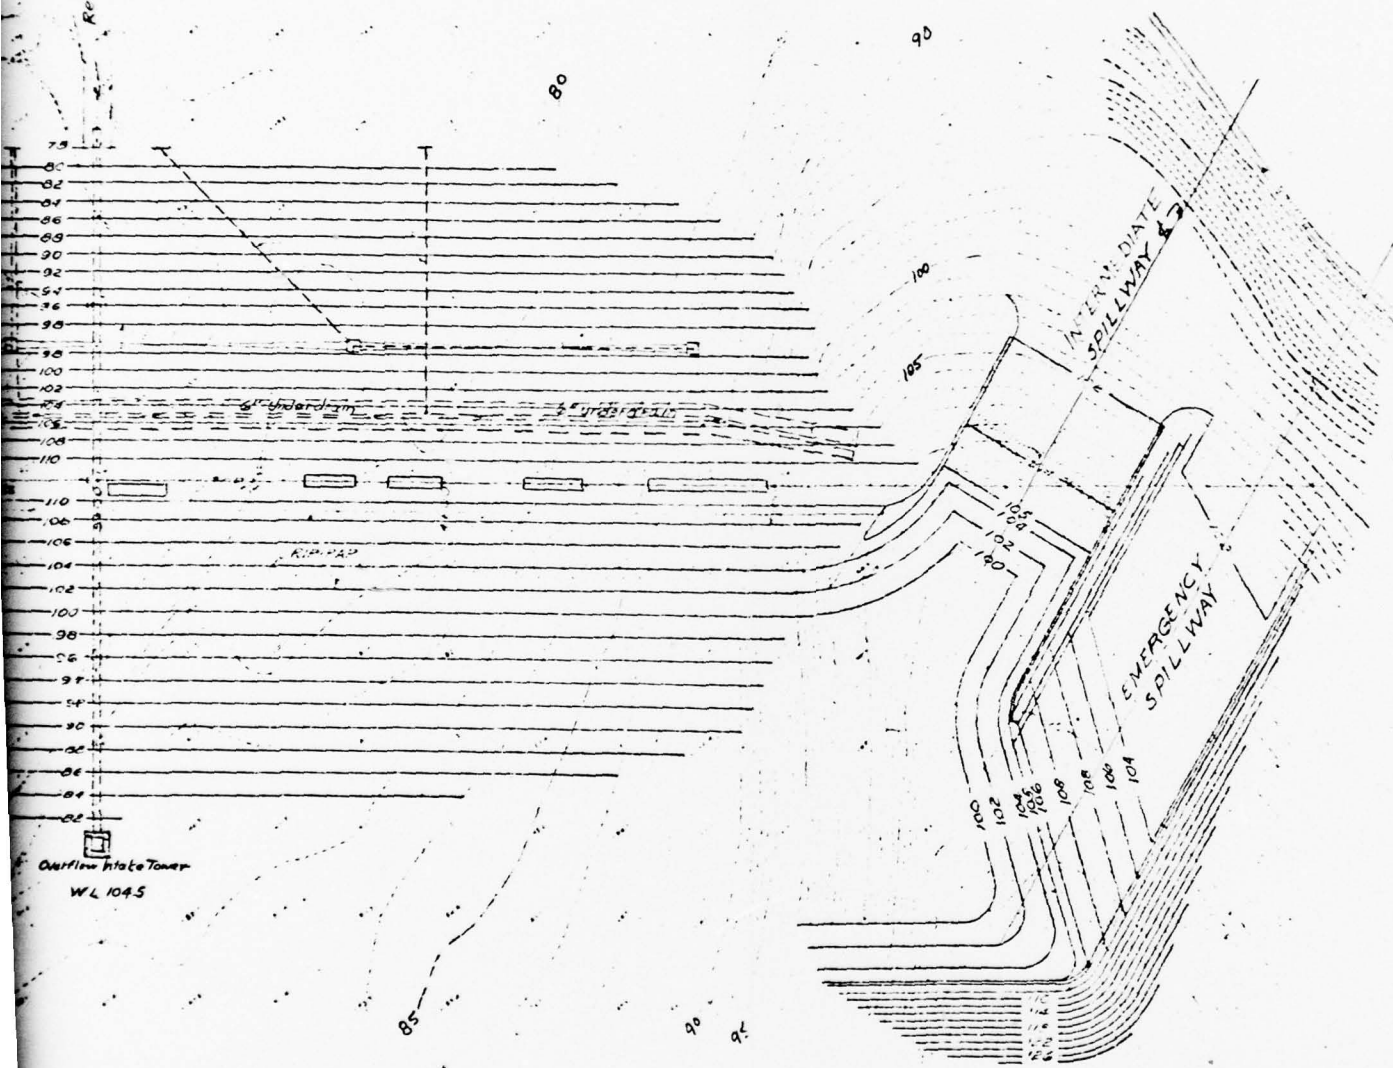
PLATE 1

PLAN OF DAM & SPILLWAY

ITEM	REMARKS
PLAN OF DAM	Plans of the dam were obtained from Camp Shenandoah. Significant differences were found between the plans and the actual construction. The available plan view of the dam is included in this report as Plate 1.
REGIONAL VICINITY MAP	The Location Plan is included.
CONSTRUCTION HISTORY	The available plans are dated 1949. Design by Wiley & Wilson, Consulting Engineers of Lynchburg and Richmond, Virginia for the Stonewall Jackson Council of the Boy Scouts of America, Staunton, Virginia.
TYPICAL SECTIONS OF DAM	Typical sections are included in the design plans. A typical section is included in this report as Plate 2.
HYDROLOGIC/HYDRAULIC DATA	Not Available
OUTLETS - PLAN AND	DETAILS are included in the design plans obtained from the camp.
